A Guide to Can Defects and Basic Components of Double Seam Containers

November 2011

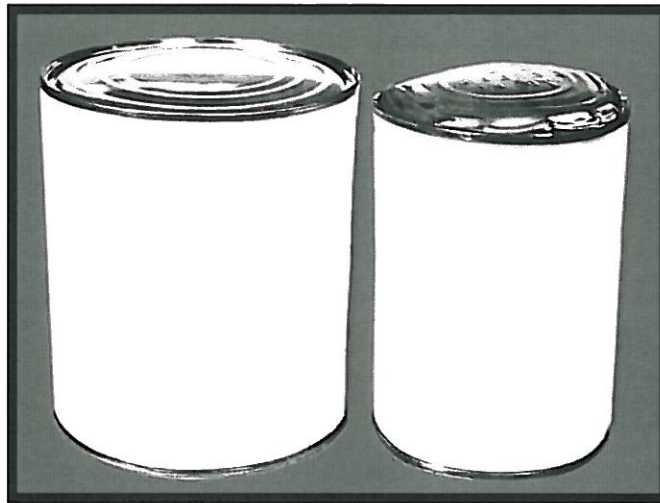
Photo 1: *Bulged and/or swollen ends from gas formation in can which causes one or both ends to swell producing a flipper, soft swell, hard swell, or blown can.*

9. **HYDROGEN SWELL:** A bulged, closed metal can caused by hydrogen produced therein by reaction of the metal with the content of the can. *(Photo 1)*

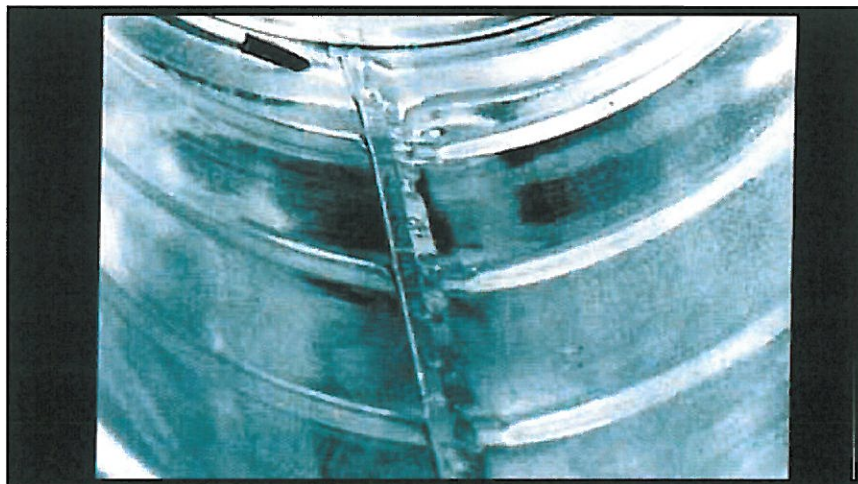
Photo 2: *Can with likely loss of hermetic seal and normally a leader due to the mislocked side seam.*

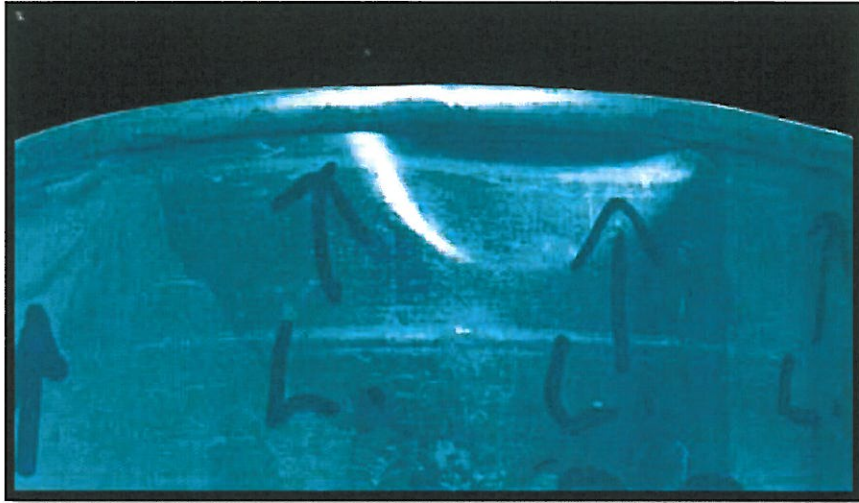
Photo 3: An opening below the double seam or plate fracture.

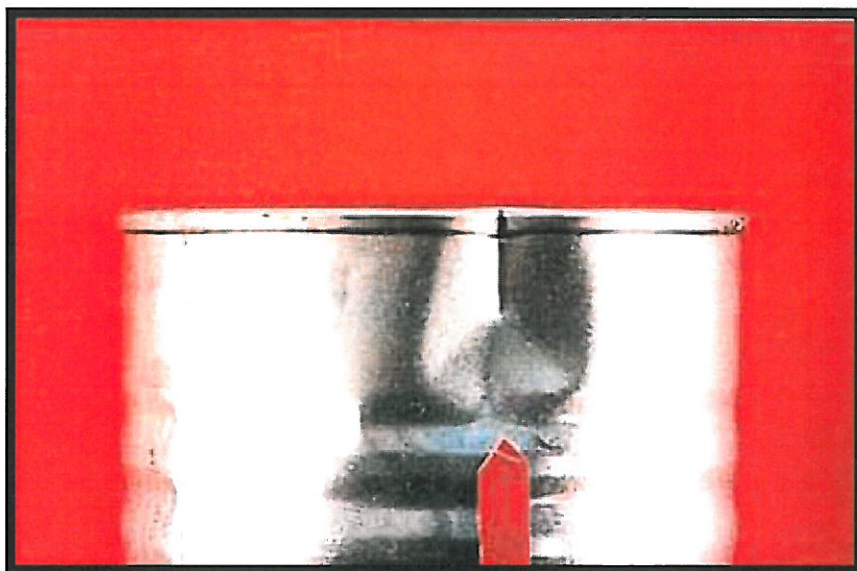
Photo 4: Plate fracture in double seam or can body. Note position of red pointer.

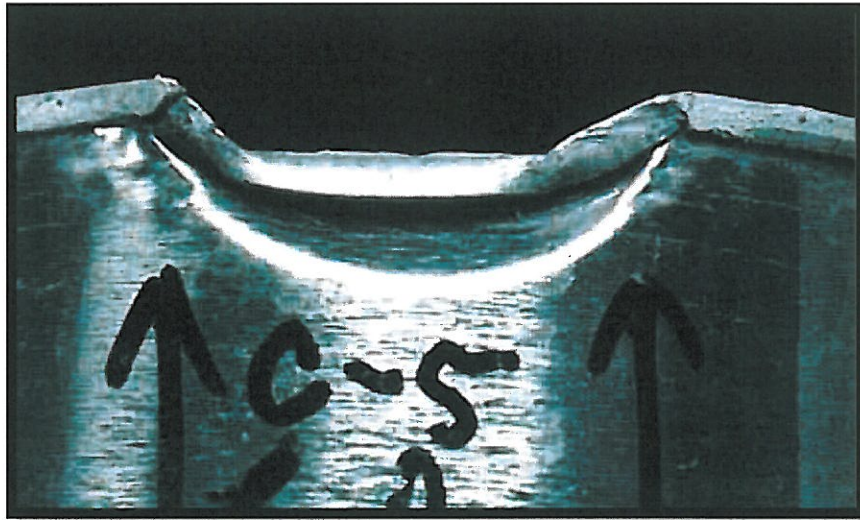
Photo 5: Severe double seam dent plate fracture.

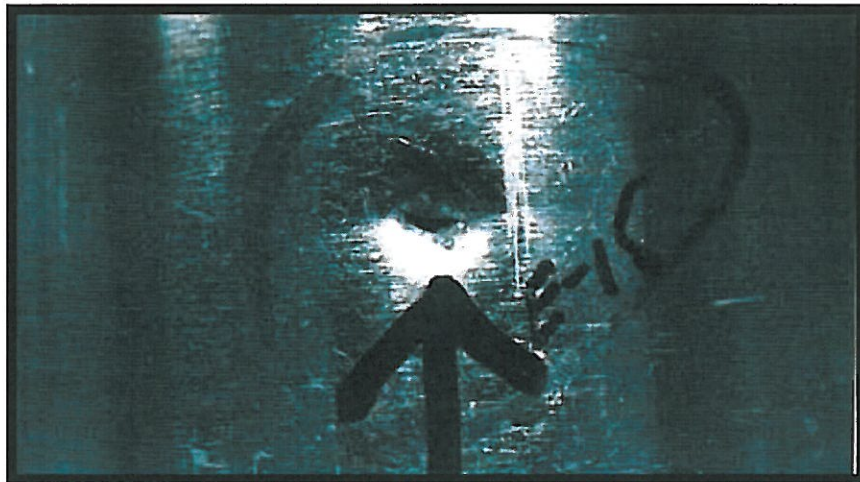
Photo 6: Puncture in can body. Pinholes in can body plate also cause loss of hermetic seal.

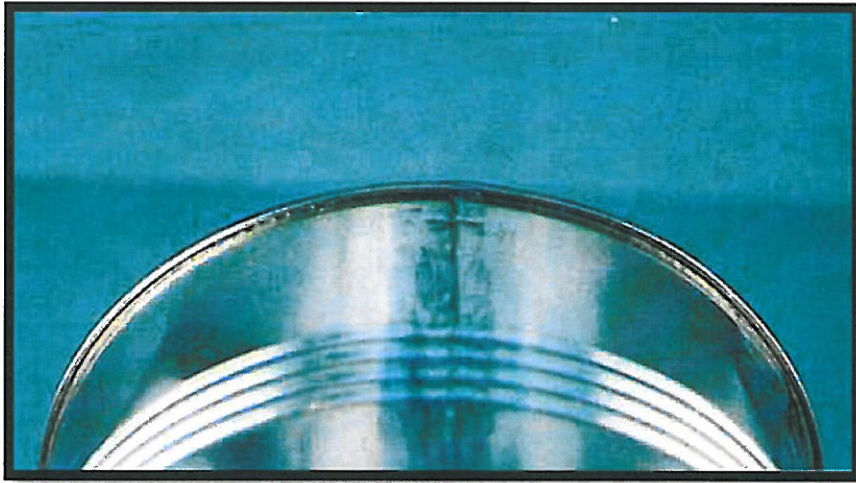
Photo 7: Closure on end of can reflects incomplete double seam (Double seaming operation not completed by manufacturer).

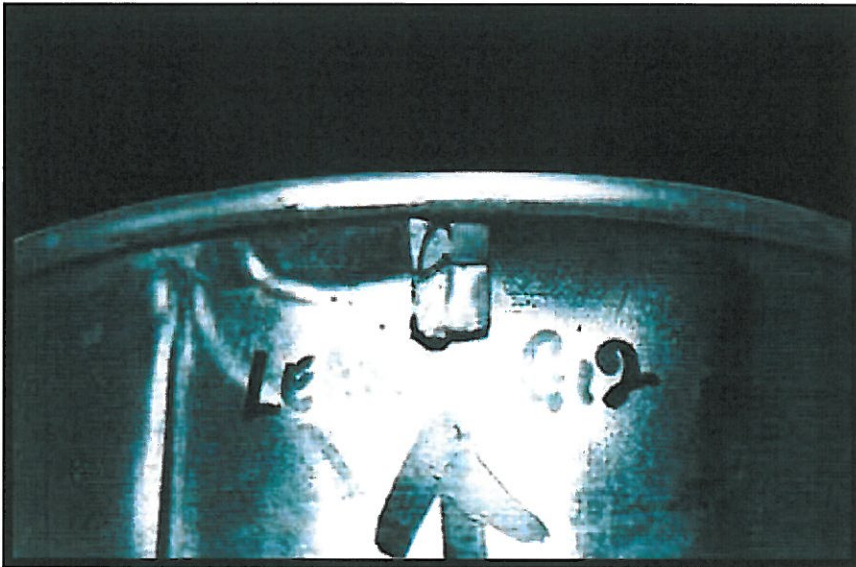
Photo 8: Defect in end of closure on can (torn flange). Note arrow pointer.

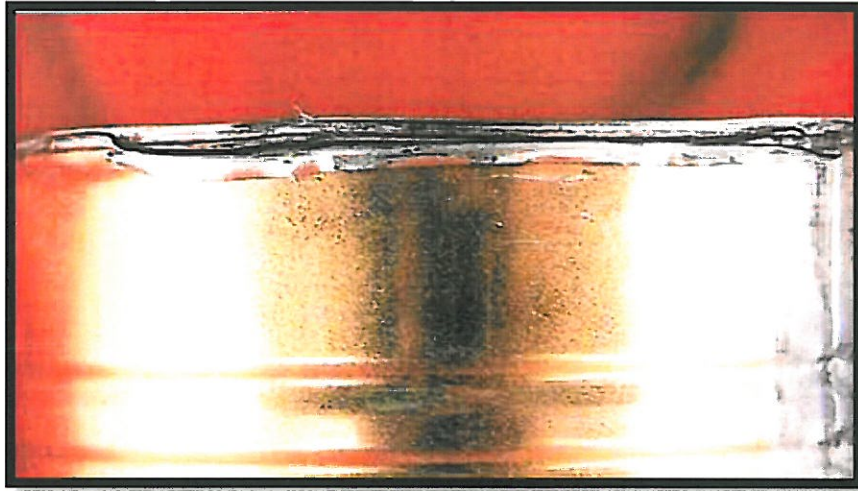
Photo 9: Depicts a **false seam** with loss of hermetic seal. Seam is formed but not engaged properly. Note knocked down flange.

3. **CUT-OVER:** A sharp break or bend in the can end metal at the seaming panel radius. *(Photo 14)*
4. **FALSE SEAM:** A significant defect in the double seam in which the cover and body hooks are not overlapped or engaged. Defect is not always detectable by simple external examination, i.e., a complete can tear down inspection may be necessary to reveal the false seam. *(Photo 9)*

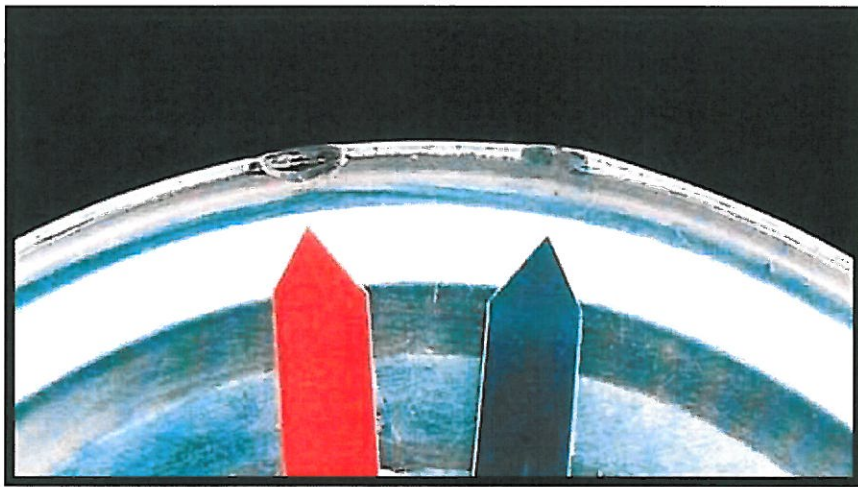
Photo 10: Example of a **cable cut** on can end. Red pointer shows "significant defect," i.e., cut through double seam. Blue pointer depicts cut/abrasion not through double seam.

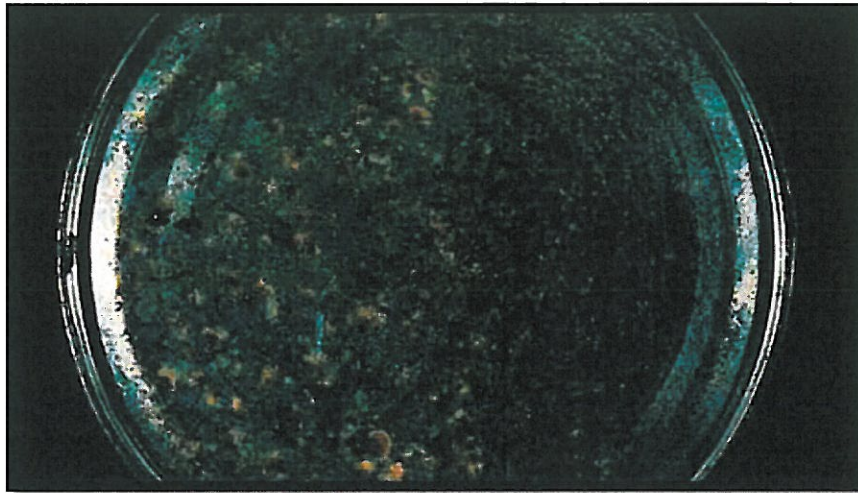
Photo 11: Severely rusted with deep pits near point of perforation.

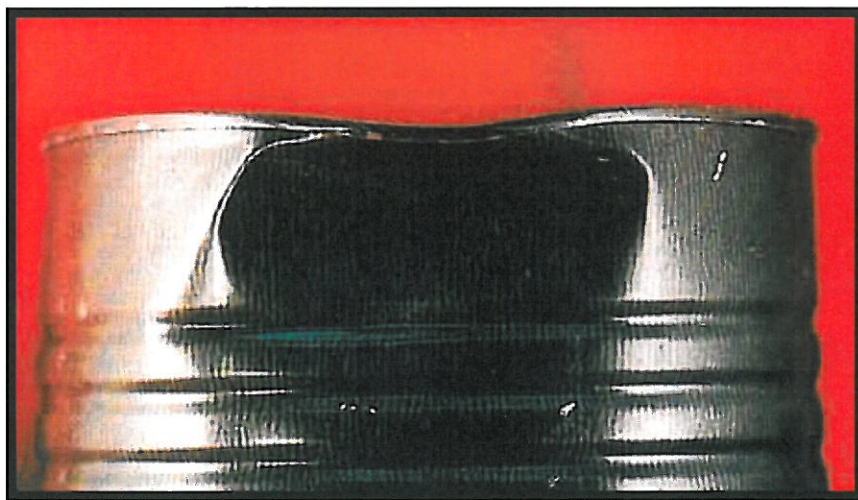
Photo 12: Major body dent which has impacted on double seam. (Plate may be fractured with loss of hermetic seal.)

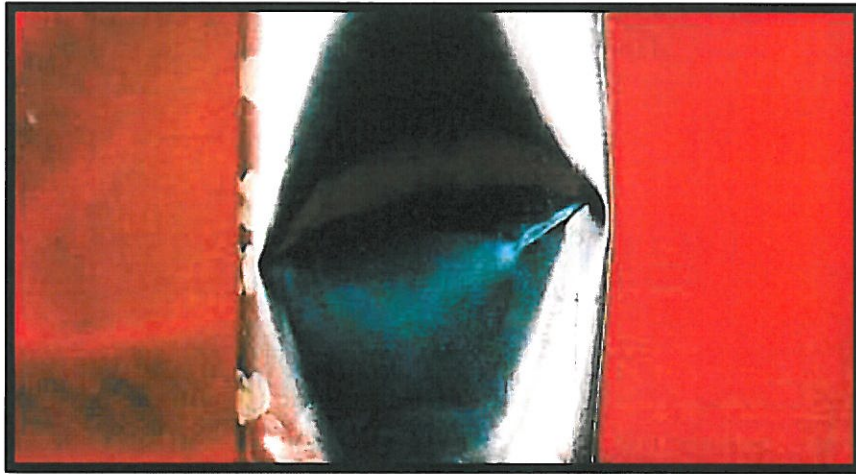
Photo 13: Major dent in center of can body. (Plate may be fractured with loss of hermetic seal.)

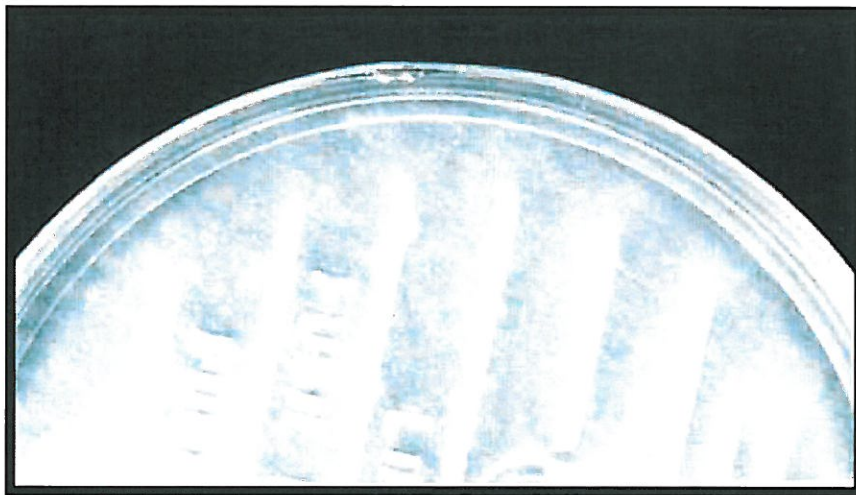
Photo 14: "Cut-over" depicting sharp seam. (Observe for potential plate fracture or loss of hermetic seal).

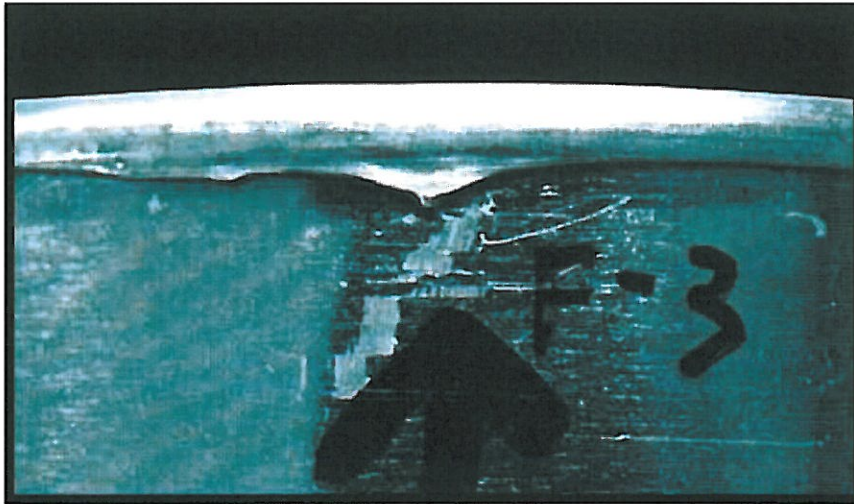
Photo 15: Defect shown termed a “vee” or “spur” with end curl knocked down. Can is a potential leaker.

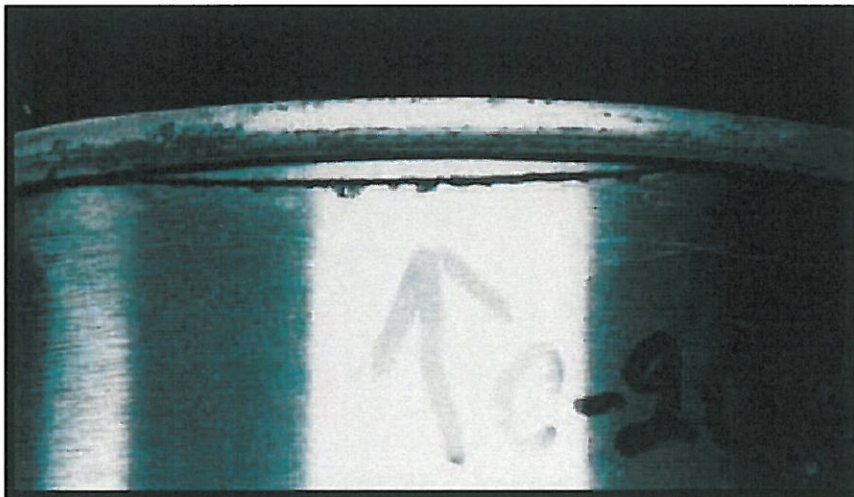
Photo 16: Pointer indicates “knocked down flange.”

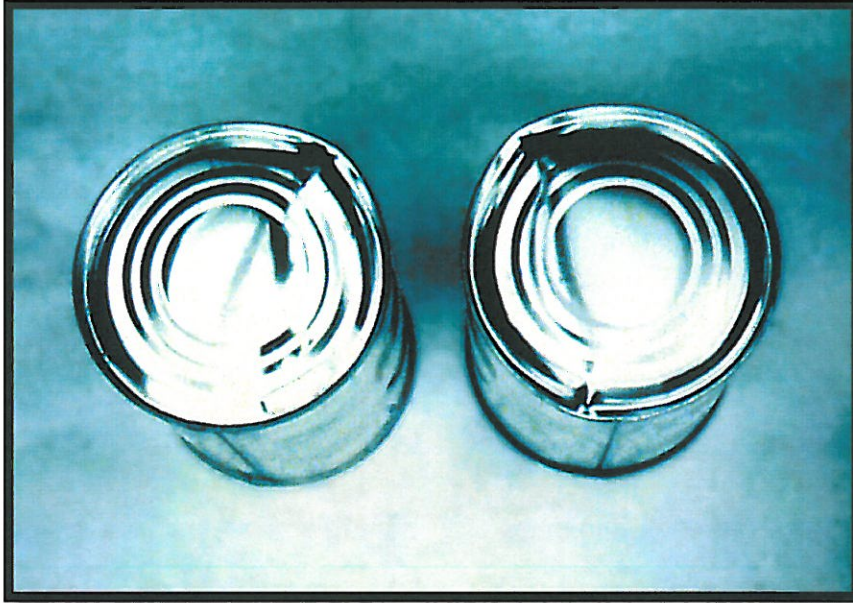
Photo 17: Cans that are buckled during retorting may leak during the cooling operation because the double seam has been strained.

1. **BUCKLE AND/OR BUCKLING:** Permanent distortion of the can end caused by excessive internal pressure. *(Photos 17 and 23)*
2. **CORROSION:** Any deterioration of the surface of the container due to a chemical reaction.

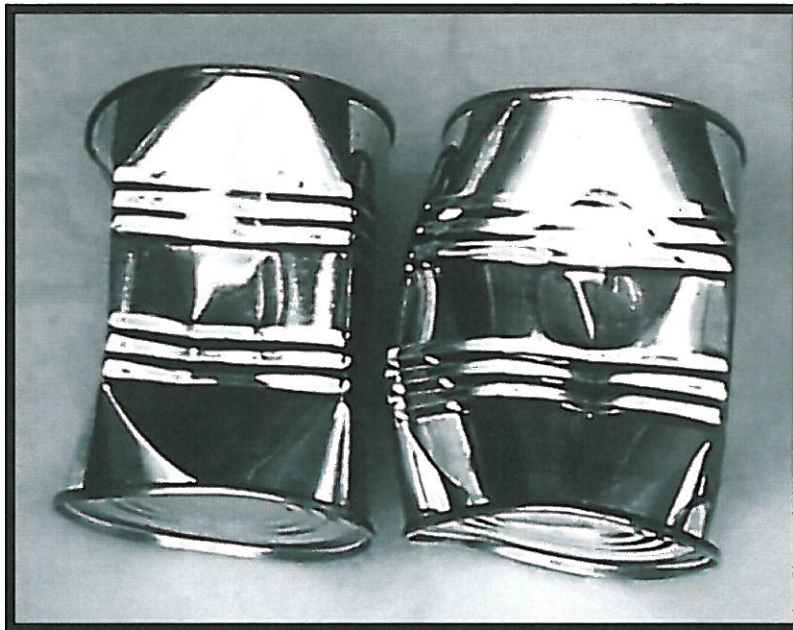
Photo 18: Cans exhibiting severe paneling of the side walls.

11. **LEAKERS:** Containers which have leaked.
12. **PANELING:** Flat sides on can body and/or permanent distortion (collapsing) of the can body caused by internal vacuum and excessive external pressure developed during processing or cooling. *(Photos 18 and 20)*

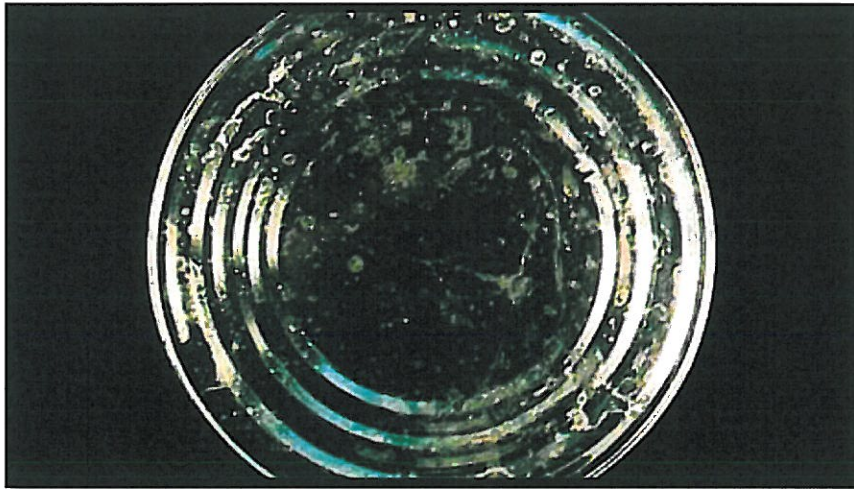
Photo 19: *Surface rust and residue food cooked on end of can. (Minor external rust and light superficial pitting easily removable by light buffing is considered an insignificant defect).*

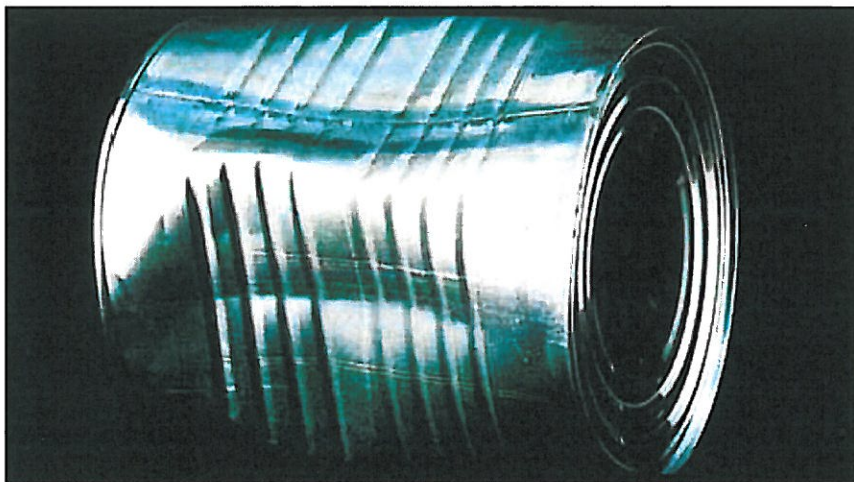
Photo 20: *Paneled container without visible signs of loss of integrity, i.e., no plate fractures.*

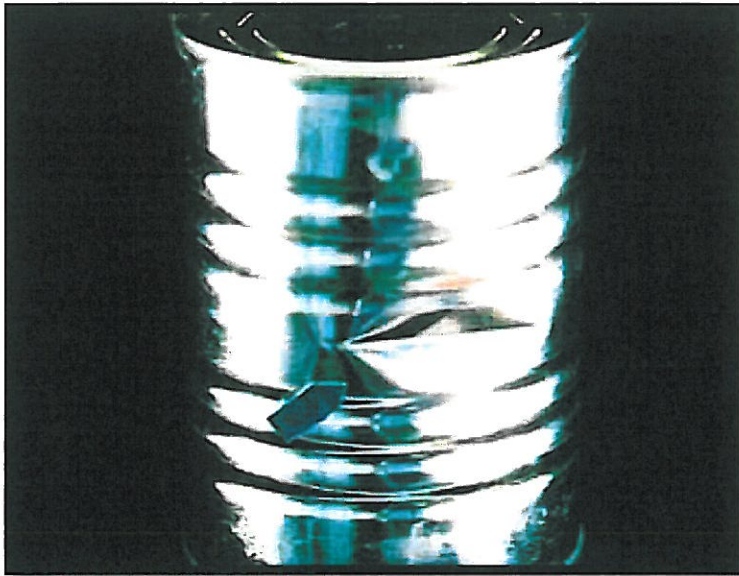
Photo 21: *Obvious body dent on side of container body. Side seam and/or double seams appear not significantly affected.*

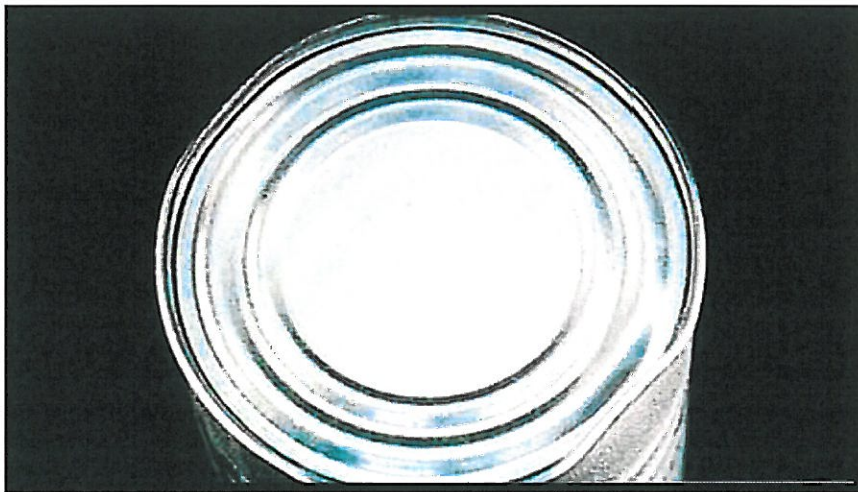
Photo 22: *Minor dent to double seam on end of can body, i.e., it does not appear creased or sharp.*

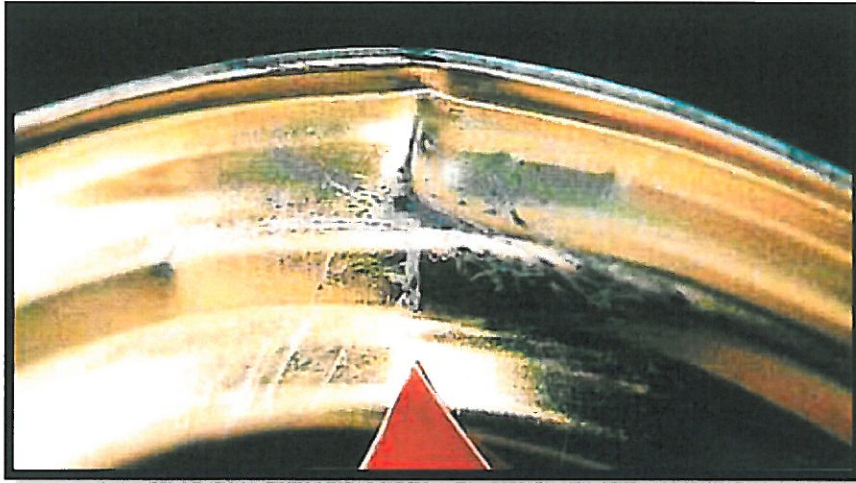
Photo 23: Minor “buckle” just extending into double seam on end of can body. (Double seam does not appear significantly affected).

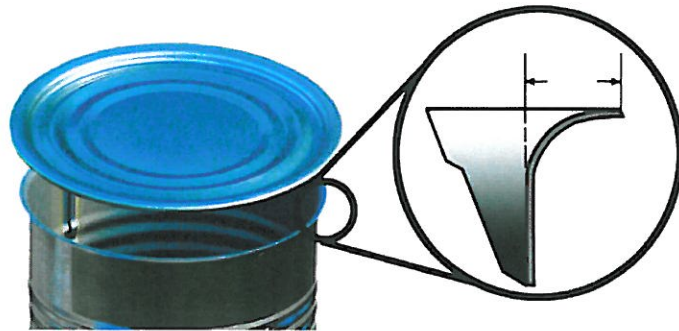
Figure 1

The **flange** is the edge of the body cylinder that is flared outward resulting in a rim or ledge and is an integral part of the double seam. The flange is formed into the body hook during double seaming and becomes interlocked with the cover hook. The width and radius of the flange are determined by can manufacturers to meet the requirements of forming a proper body hook during the double seaming operation (*Figure 1*).

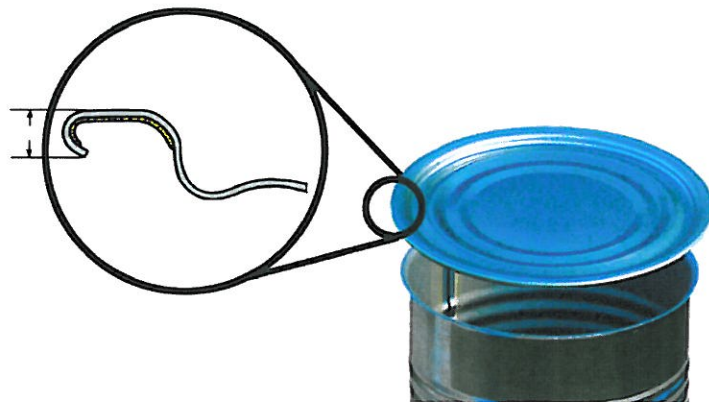
Figure 2

The **end curl** -- sometimes referred to as cover curl -- is designed to provide sufficient metal to form a good cover hook. Important in the design are proper curl, a proper base for sealing compound application, and easy feeding of end units into the closing machine (*Figure 2*).

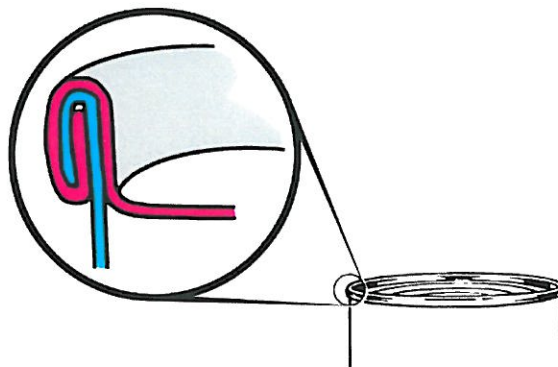
Figure 3

A double seam is that part of the can formed by joining the body of the can and the end (sometimes referred to as the cover). The body flange and the curl of the end interlock during the double seaming operation to form a strong mechanical structure. Each double seam consists of three thicknesses of the can end and two thicknesses of the can body with an appropriate sealing compound distributed through the folded metal to form a hermetic seal (*Figure 3*).

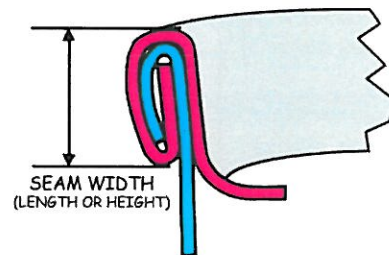
Figure 6

Seam Width (Length or Height) -- Seam width, also referred to as seam length or height, is the dimension measured parallel to the hooks of the seam (*Figure 6*). This dimension is somewhat dependent upon the groove contour of the second operation seaming roll.

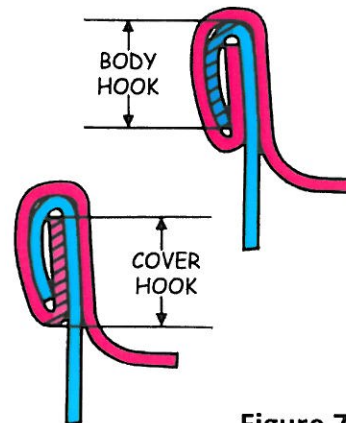
Figure 7

Body Hook and Cover Hook -- The body hook, whose origin was the body flange, and the cover hook, which was formed during the double seaming operation from the end curl, reflect the internal aspects of the double seam. These two structures observed in a cross-section appear in an interlocking relationship to each other (*Figure 7*).

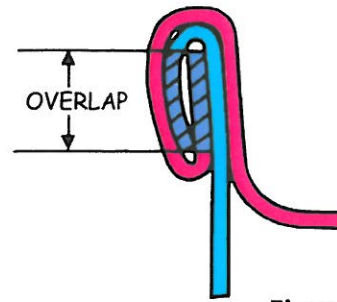
Figure 8

Overlap -- The degree of interlock between the body hook and cover hook is known as overlap (*Figure 8*).

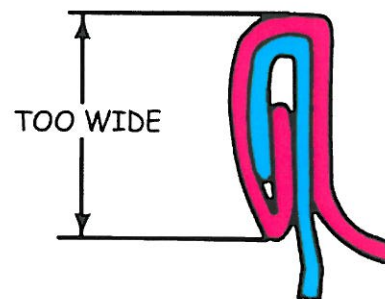
Figure 15

Excessive pressure in the second operation does not produce a good seam and may stretch the metal, causing an increase in the width (height or length) of the seam and an unhooking or reduction of the overlap (*Figure 15*). An excessively tight second operation seam may also cause sharp seams, as well as compound squeezing out of the seam. A tight seam is more likely to leak than one made with normal pressures. This condition was more pronounced at the side seam lap of soldered cans. Possible causes of an excessively tight second operation double seam are:

- Improper setting of second operation seaming roll; and/or
- Body and/or end plate abnormally thick.

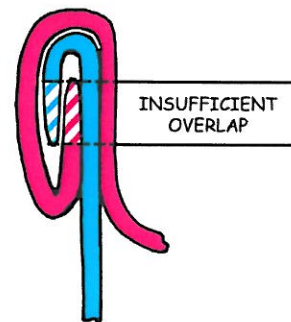
Figure 18

Insufficient overlap exists when the interlock between body hook and cover hook is less than recommended guidelines (*Figure 18*). Sufficient overlap is necessary to form a satisfactory hermetic seal. Possible causes are:

- Can body flanges out of specifications;
- Cover end curls out of specifications; and/or
- Poor adjustment of the closing machine.

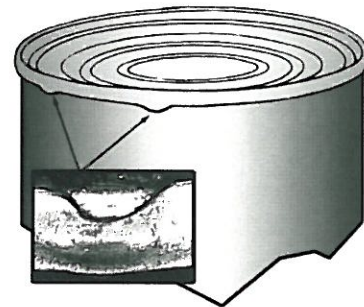
Figure 19

A smooth projection of a double seam below the bottom of a normal seam is identified as a droop. This may occur at any point around the seam (*Figure 19*). Possible causes of droop are:

- Excessive body hook;
- First operation too loose;
- Worn first operation rolls or roll bearings;
- Cocked can bodies;
- Product trapped in steam;
- Excessive amount or unequal distribution of end seaming compound; and/or
- Can flange or end curl defect.

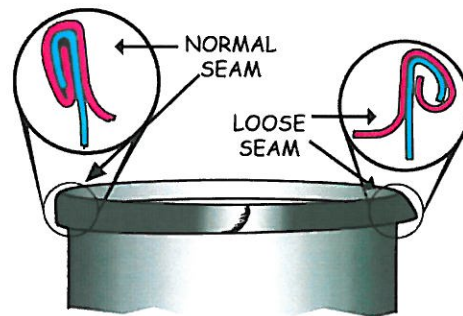
Figure 20

A deadhead is an incomplete seam caused by the chuck spinning in the countersink of the end during the seaming operation (*Figure 20*). This seam defect is also known as a "spinner," "skidder" or "slip." Possible causes include:

- Incorrect baseplate pressure;
- Improper end-fit with seaming chuck;
- Worn seaming chuck;
- Seaming rolls binding (not freely rotating);
- Oil or grease on chuck;
- Excessive vertical play of seaming chuck spindle;
- Incorrect pin-gauge setting (seaming chuck too high in relation to baseplate); and/or
- Lifters not rotating freely.
